The Pivot of Defence of Upper Canada: An Overview of the Structural History of Fort Henry

Bob Garcia

Introduction: The Planning and Construction of Fort Henry

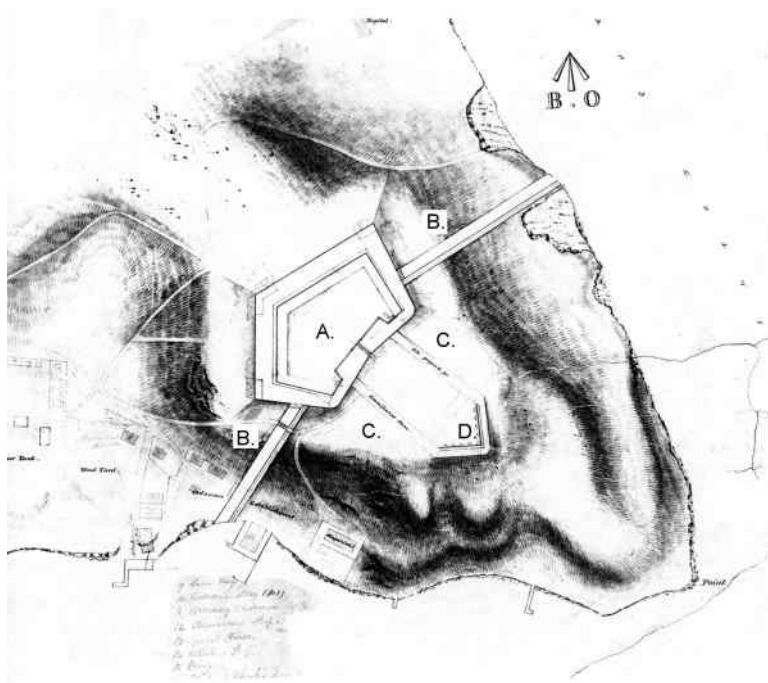
Figure 2. *The proposed Fort Henry, 1829. A. Redoubt, B. Branch Ditches, C. Commissariat Stores and D. Advanced Battery. Library and Archives of Canada, NMC 4540.*

Fort Henry would have four parts (Figure 2). The first would be a masonry redoubt, whose guns would cover the ground to the north, surrounded by a substantial *ditch* that held reverse-fire chambers for close-in defence. The second feature would be the Advanced Battery (AB), located behind the redoubt and covering the lake approach to the fort. The third element would be casemated storerooms for the Commissariat Department. These twin buildings would link the redoubt to the AB. The final components were the two branch ditches: projecting outwards from the redoubt's ditch and extending down to the water's edge, these branch ditches would enhance the security of military structures on the southern portion of Point Henry.

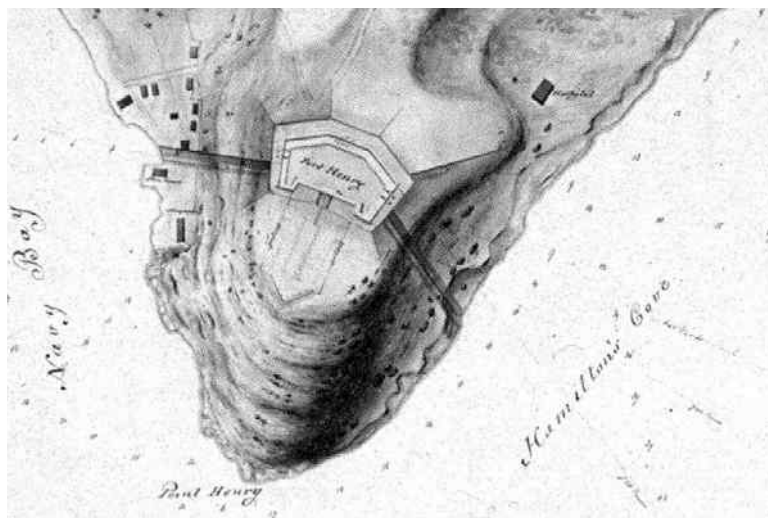
Figure 3. *Fort Henry, 1835. The plan shows the additional front added to the northern side of the redoubt by Lieutenant Colonel Nicolls. Library and Archives of Canada, NMC 22430.*

Work on Fort Henry commenced in 1832 and was substantially completed by 1837. Prior to construction, Colonel Gustavus Nicolls, Commanding Royal Engineer in Canada, modified the redoubt design and added a third face to its

northern side to better cover the *glacis* (Nicolls 1832, Figure 3). Constructed of locally quarried limestone, the redoubt’s casemates were arched in eight layers of brick. The northern casemates had two levels, providing quarters on the upper and storage on the lower while the officers were housed in the single level west and east casemates. The *curtain wall* on the south side of the redoubt contained the privies, guardrooms and additional storage and a magazine located in the northeast corner held 1,000 barrels of gunpowder. The garrison’s water supply was held in large cisterns, capable of holding 182,000 litres, built under the eastern end of the redoubt’s *parade* (Holloway 1849).

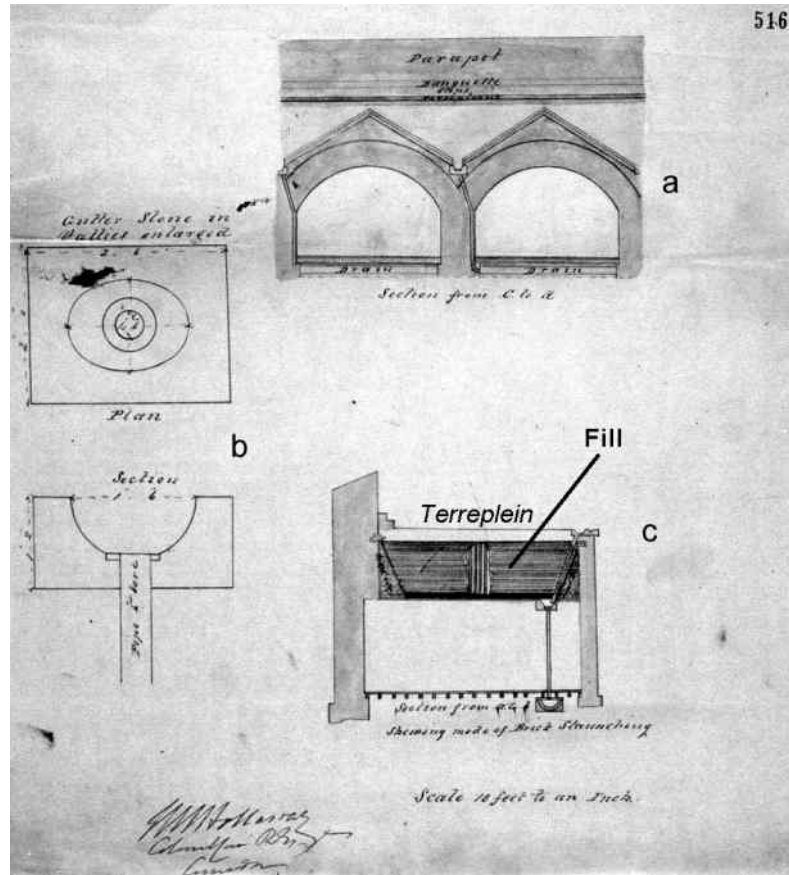
Figure 5. Colonel Holloway's alterations to Fort Henry: a profile of the redoubt showing the routes of the drainpipes through the brick arches to drains beneath the floors of the casemates (a); one of the new stone drains installed under the terreplein (b); a section illustrating the drainage from the terreplein through pipes to the sub-floor drains (c). Also indicated is the area of fill that was removed to facilitate the asphaltting of the casemate arches. The National Archives:Public Record Office, WO55/882, f. 516.

leaking in the redoubt. Asphalt was laid over the terreplein, but this proved a temporary fix. In the mid-1840s Colonel William Holloway, the Commanding Royal Engineer in Canada, executed a major revamp of the redoubt by lifting the fill from the terreplein, asphaltting over the casemate arches and rerouting the drainage of water (Holloway 1848, Figure 5). This seemed to work for a few years, but by 1854 the terreplein again needed excavation for the leaks to be sealed. In addition, the superior slope of the parapet was repointed. Even this was not enough to stop the leaking and between 1858 and 1861 the engineers covered the parapet with a roof-like structure of wooden boards (Servante 1863). In 1862 the fill above the officers’ casemates had to be removed and part of the interior wall rebuilt to stop the leaking (Servante 1861). This ongoing battle with water was in stark contrast to the Commissariat Stores: during the initial construction, the installation of a proper roof undoubtedly saved these casemates from the fate of those in the redoubt.

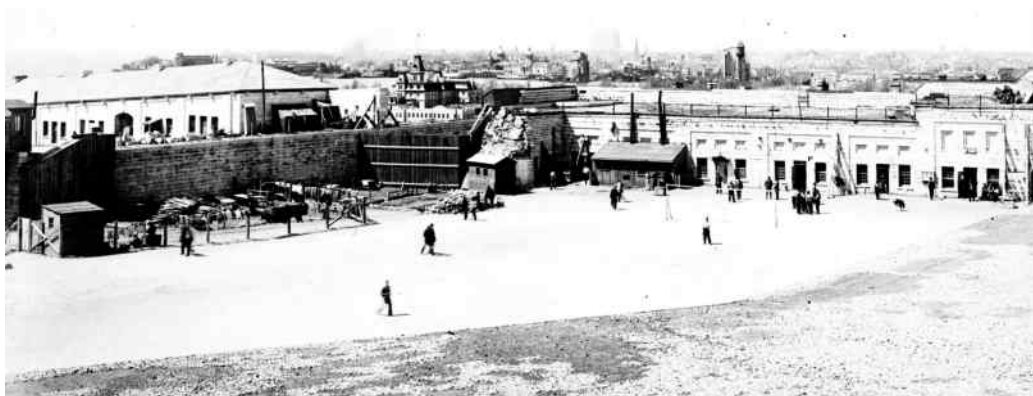
Figure 6. Fort Henry as a Prisoner of War camp in the First World War. Library and Archives of Canada, C-017323.

Figure 7. *East officers' casemates, 1931. Archives of Ontario, I0002554.*

and later for German military prisoners (Figure 6). Canadian engineers installed security measures and a new roof over the terreplein of the redoubt, but the long neglected fort provided less than ideal living conditions for its inhabitants. The badly pointed masonry allowed water into the casemates and the walls of the former officers' quarters had to be propped up to prevent them from collapsing (Royal Canadian Engineers 1915). In 1917 the site closed and the prisoners transferred to other camps.

Through the 1920s and into the 1930s the Canadian military continued to use the redoubt and Commissariat Stores to house ammunition and supplies. Very little, if any, money went into the maintenance of the redoubt and, as a result, water infiltration continued. The walls of the ditch surrounding the fort crumbled, as did sections of the walls on the exterior and interior of the redoubt. By the mid-1930s sections of Fort Henry were indeed a ruin (Figure 7).

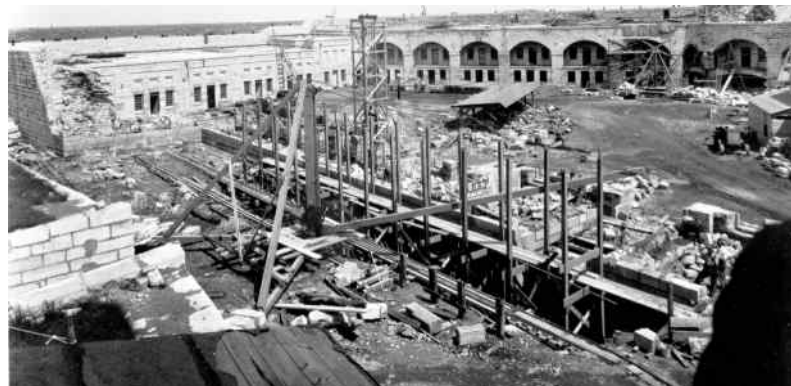
Figure 8. *The reconstruction of the curtain wall during the 1936-1938 restoration. Fort Henry Archives.*

costing over \$800,000, was undertaken to rebuild the redoubt, the branch ditches and towers, and completely reconstruct the curtain wall (Way 1965, Figure 8). Work crews lifted the terreplein again and installed a concrete slab in hopes of forestalling the penetration of water. The fort was literally reborn and the overall appearance of the site today reflects the work done in the 1930s.

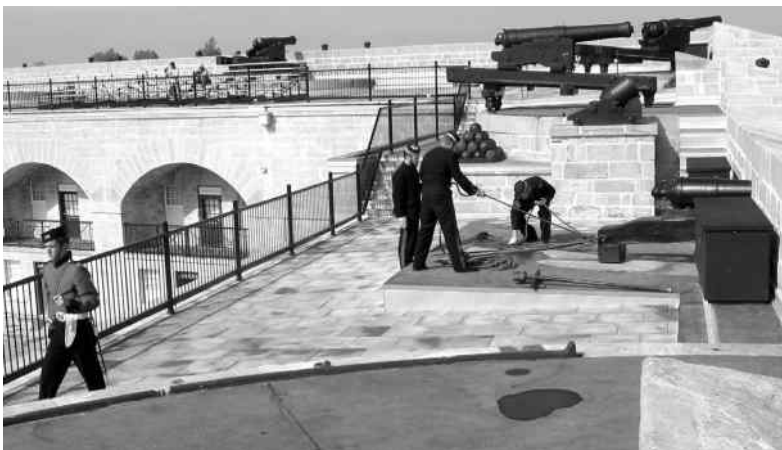
Figure 9. *The rehabilitated terreplein above the east officers' casemates, summer 2005. Parks Canada, 2005.*

Parks Canada assumed federal administrative responsibility of Fort Henry in 1999. Operation of the site remained in the hands of the St. Lawrence Parks Commission, an agency of the Province of Ontario. Recognizing that the site once again needed urgent work to preserve its built heritage, the federal and provincial governments contributed a total of \$15 million for a stabilization project. Since 2002 this endeavor has addressed the most urgently needed repairs. To date, the entrance cutting leading from the Commissariat Stores to the redoubt has been repaired and repointed, and the Commissariat Stores roof, lightning protection and eavestroughs have been replaced. Work is proceeding on the stone replacement, waterproofing and repointing of the

redoubt and should be complete by late 2006 (Figure 9). Stabilization of the Branch Ditch Towers should also commence in 2006.
